PROPOSAL**RAYMOND E. KELLEY, INC.**

PROPOSAL SUBMITTED TO Warren County School District	PHONE (814) 723-6900	FAX	DATE 8/31/15
STREET 6820 Market Street	JOB NAME Eisenhower MS/HS Masonry Repairs		
CITY, STATE & ZIP CODE Russell, PA 16345	JOB LOCATION 3700 Route 957, Russell, PA 16345		JOB PHONE
ATTENTION Mr. Norbert Kennerknecht	ARCHITECT n/a		DATE OF PLANS

BASE BID - Masonry Repairs

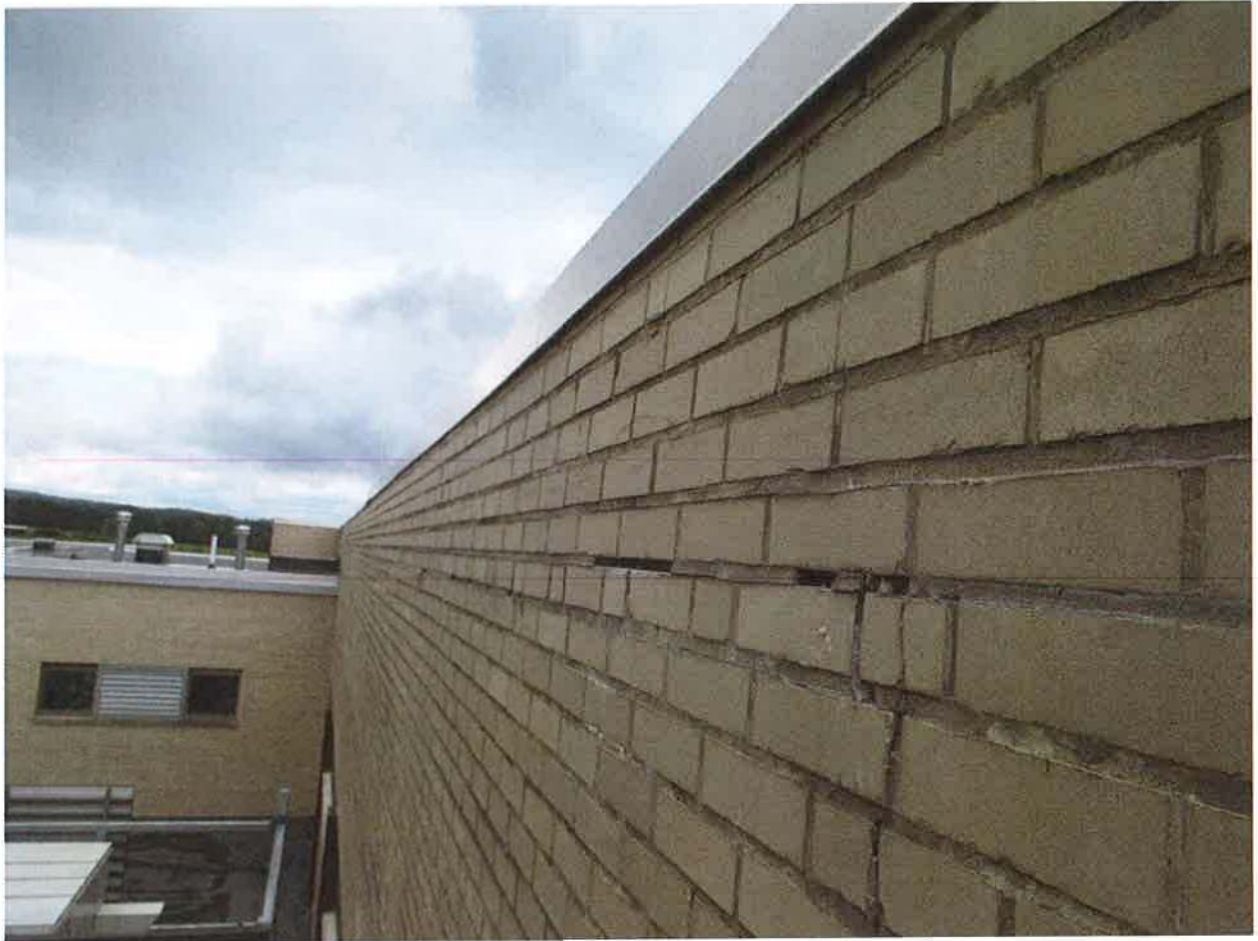
1 – Failed mortar at top of South Gym wall.

- Repointing of mortar joints as noted. The minimal amount of repointing is included as can be determined at this time. Once the areas have been cleaned, a better assessment of the amount of repointing can be determined.

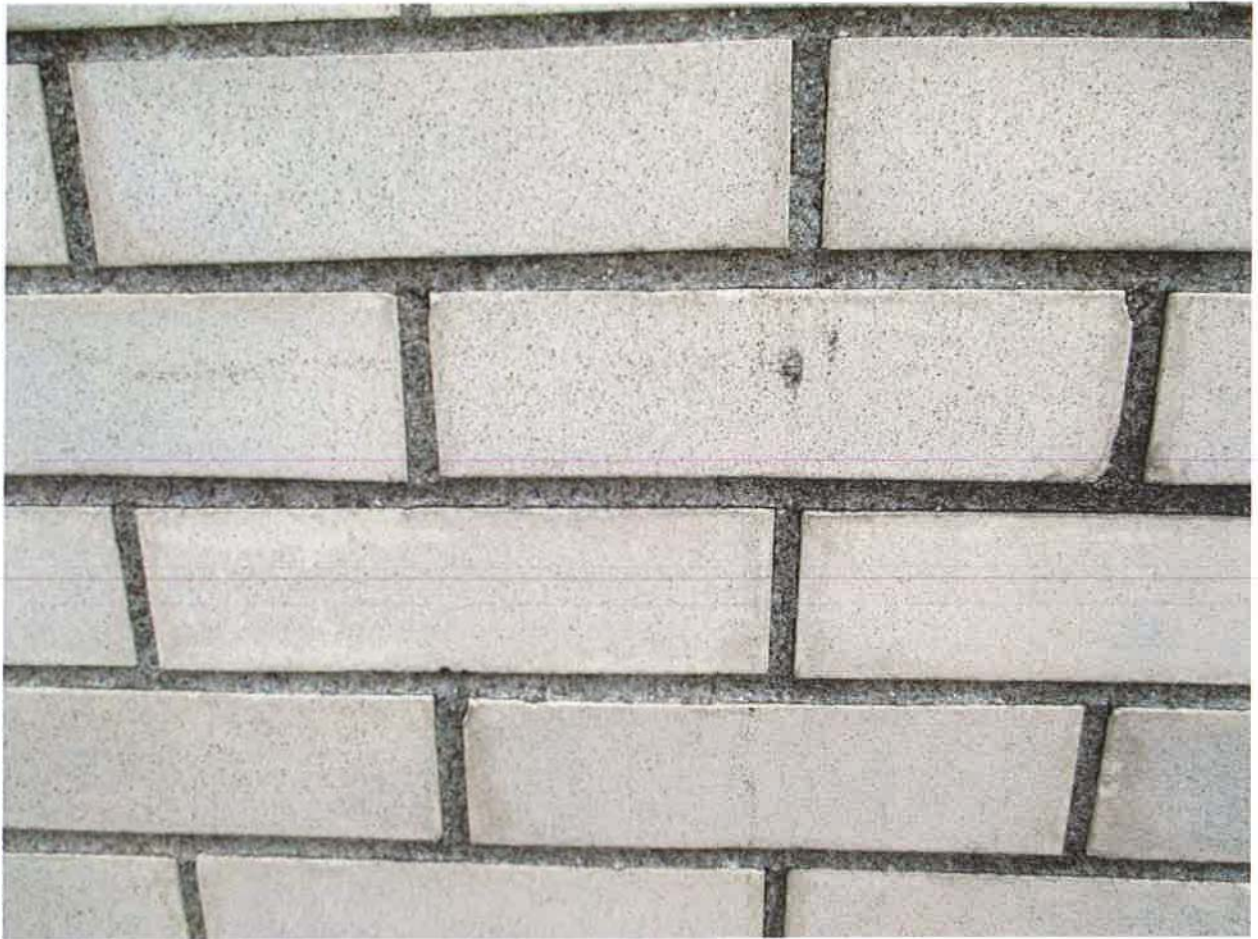
7- Typical brick veneer with noticeable dirt and mildew.

- Please see the accompanying marked-up drawings A2.1, A2.2 & A2.3 for the included scope of work.
- Cleaning of noted brick and mortar surfaces by use of power-washing and masonry detergent cleaning solution to remove dirt and mildew.

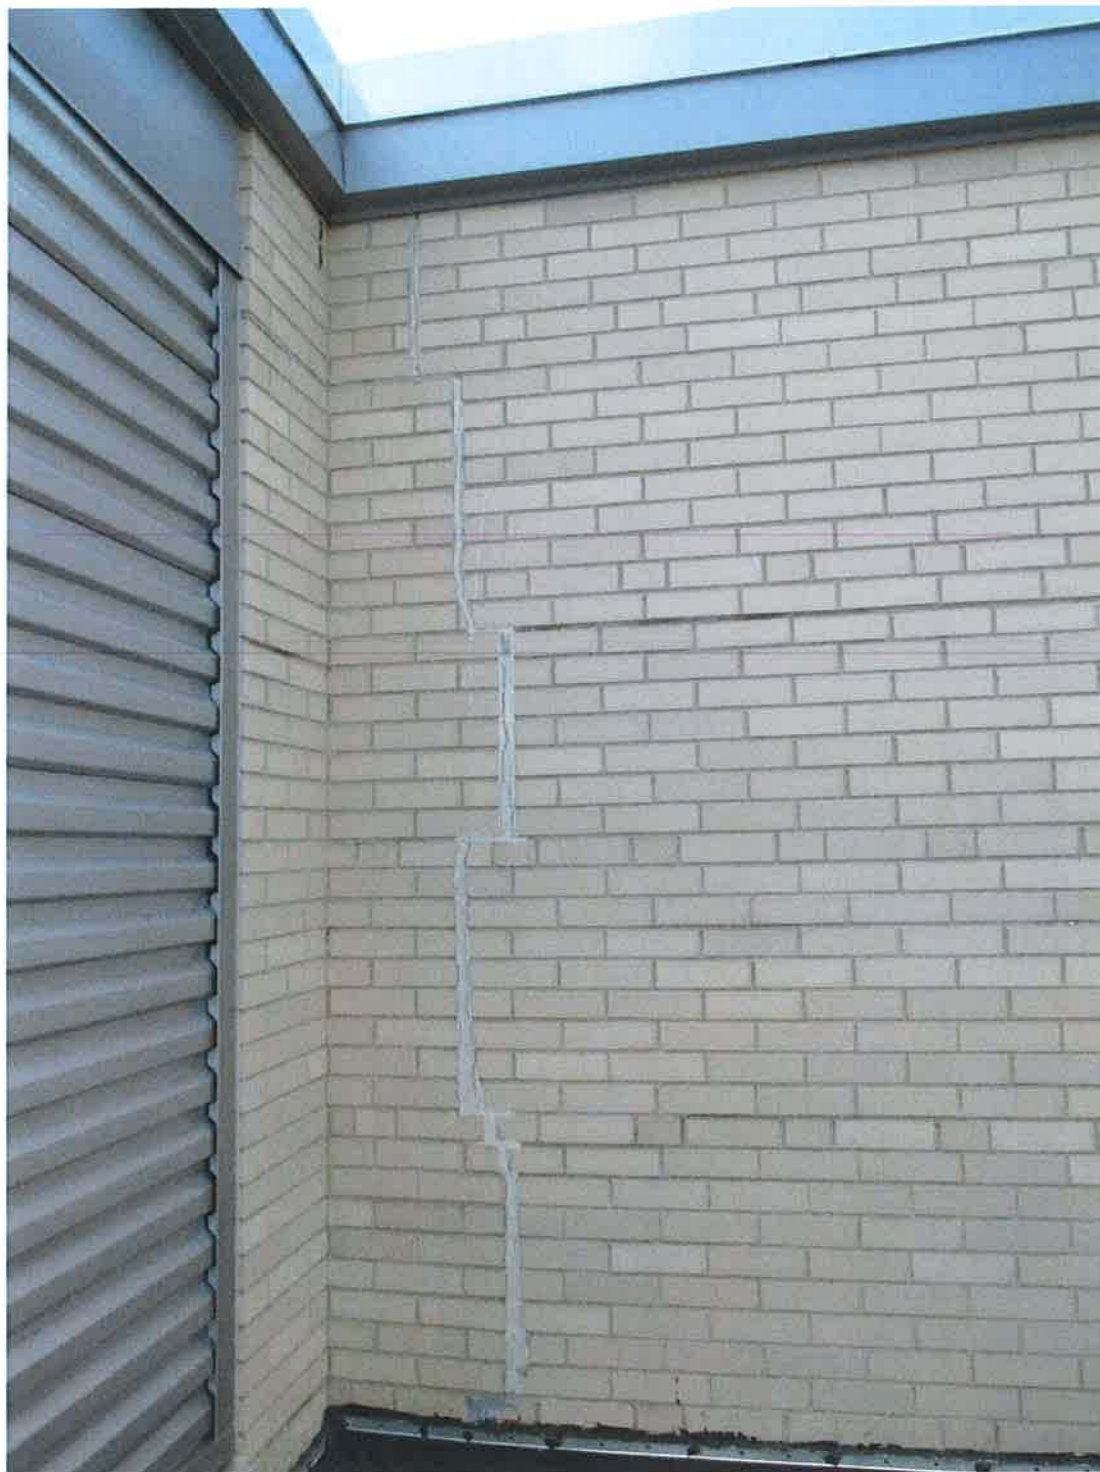
33 - Crack in brick veneer that has been repaired but evidences continued movement.

- There are numerous hairline cracks evident throughout the structure that are not included.
- Remove and replace joint sealant as noted. Some of the noted joint sealant work (i.e. sill ends) is in the new/recent work that was overlooked.

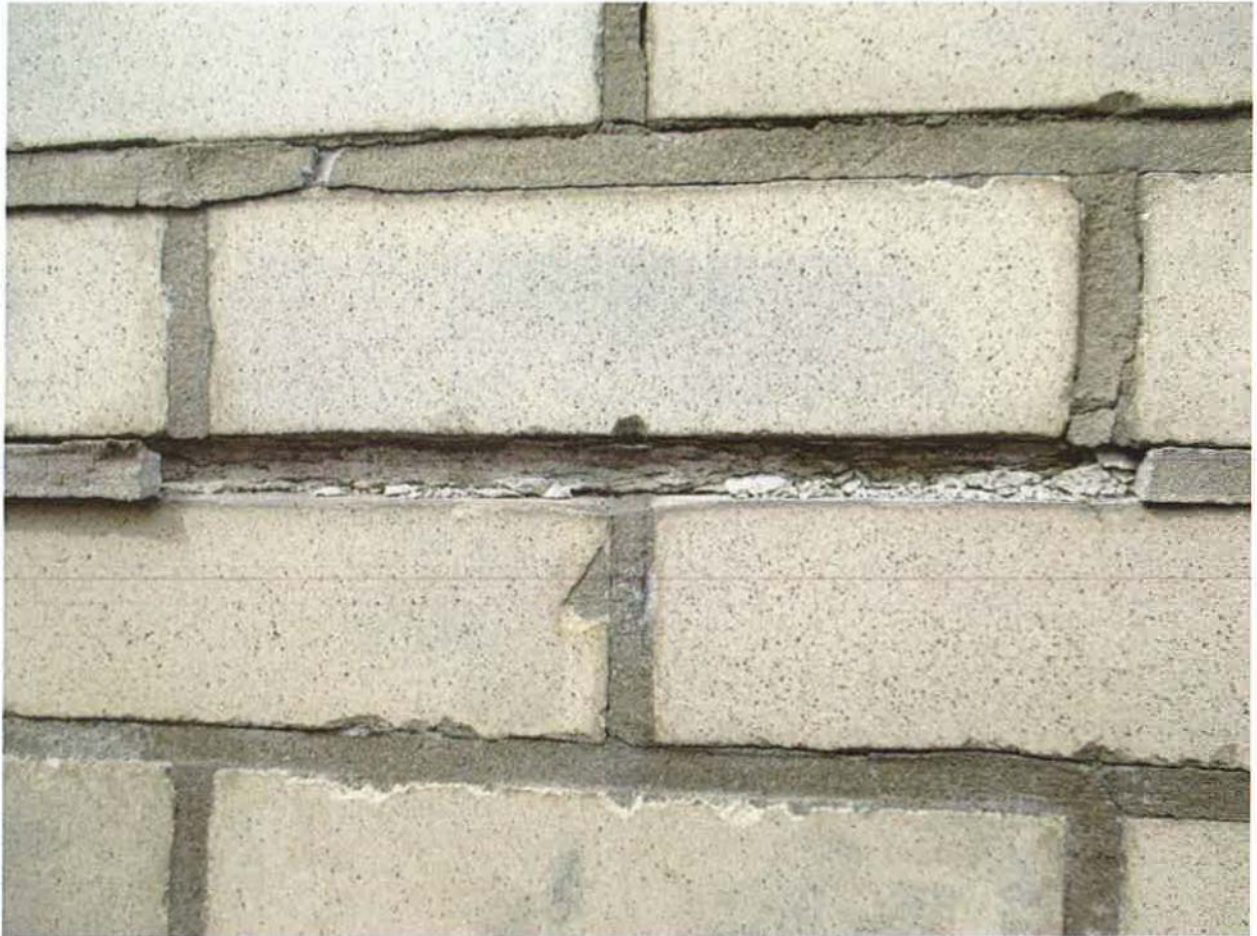
50 – Example of improper repointing. The shallow depth of the repair has led to failure, moisture intrusion and and deterioration of the remaining backup mortar.

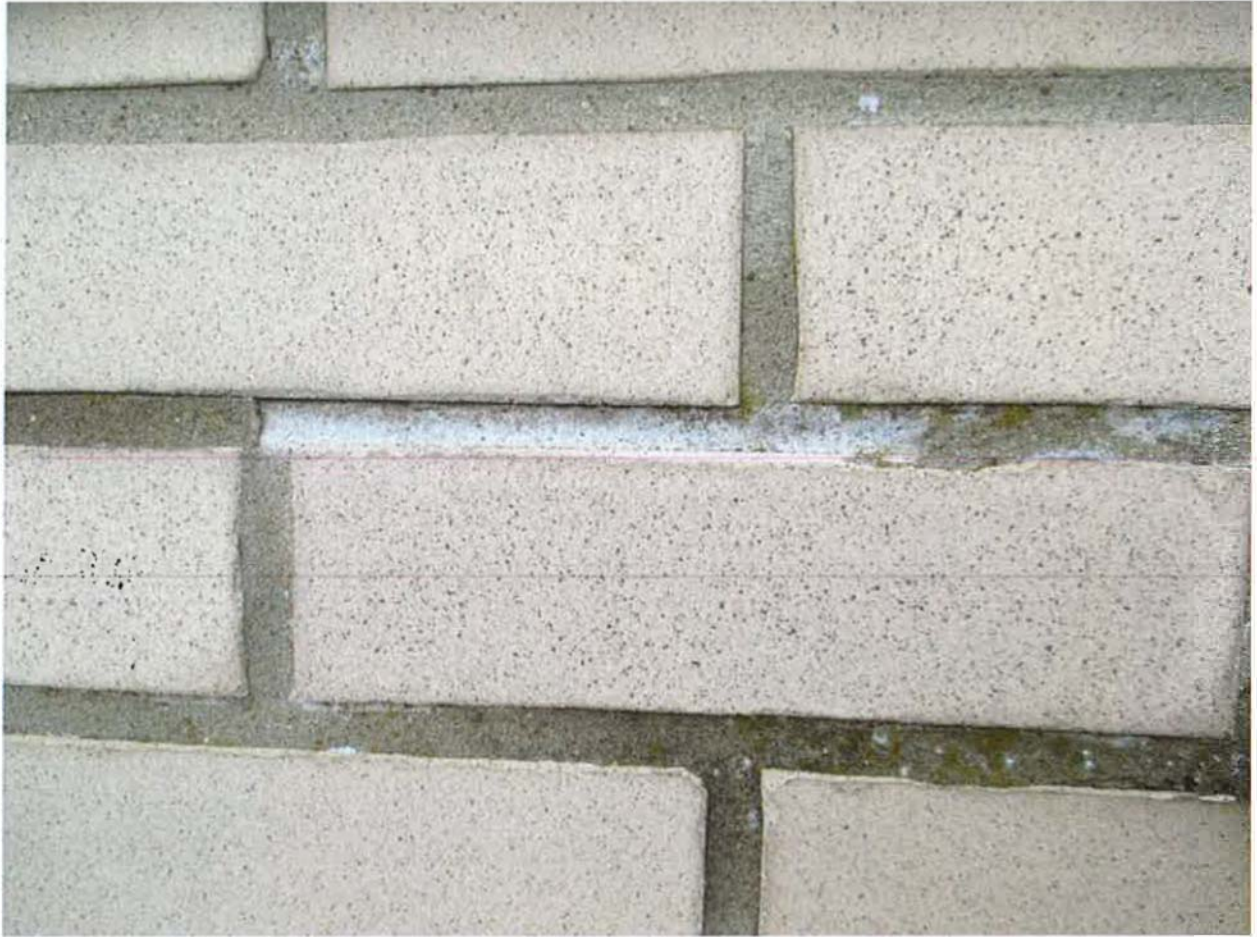
53 – Example of very shallow repointing. Some large areas were repaired with this method.

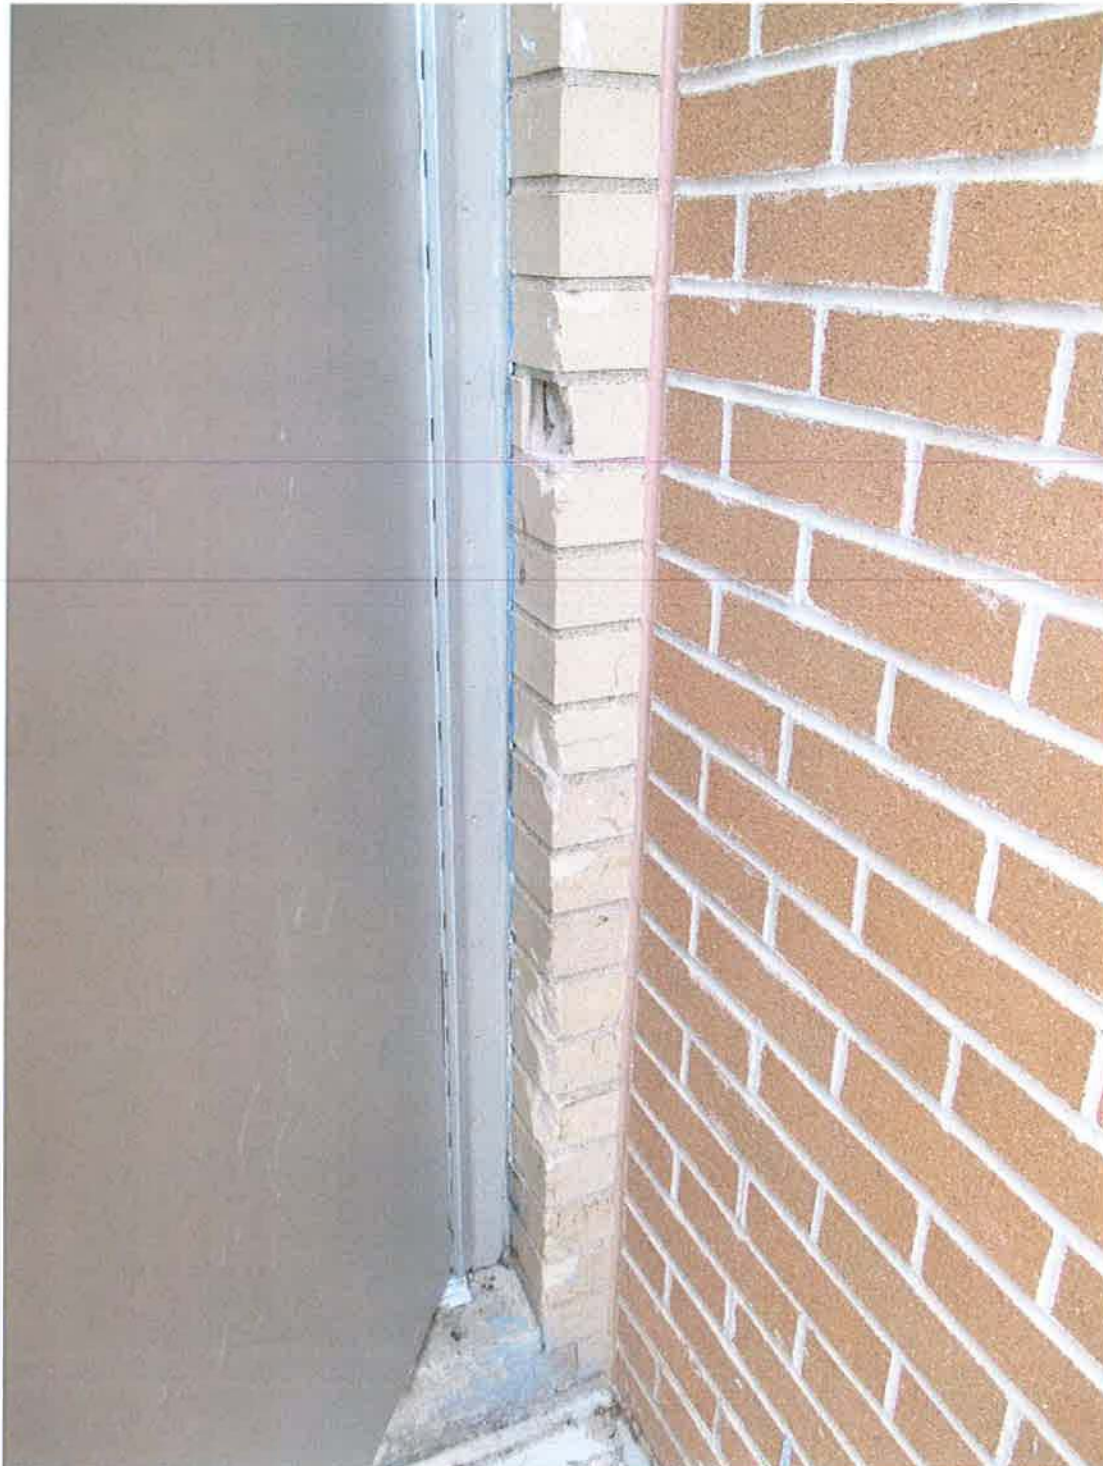
131 – Damaged brick

- Brick replacement in areas where the brick have:
 - o cracked more than a hairline crack
 - o have been previously repaired via repointing that is failing or is the wrong color mortar

- o have been damaged or chipped
 - o in some cases are unsightly due to the wrong color of brick used in a previous replacement
- All areas of replacement to be verified in field prior to replacement.

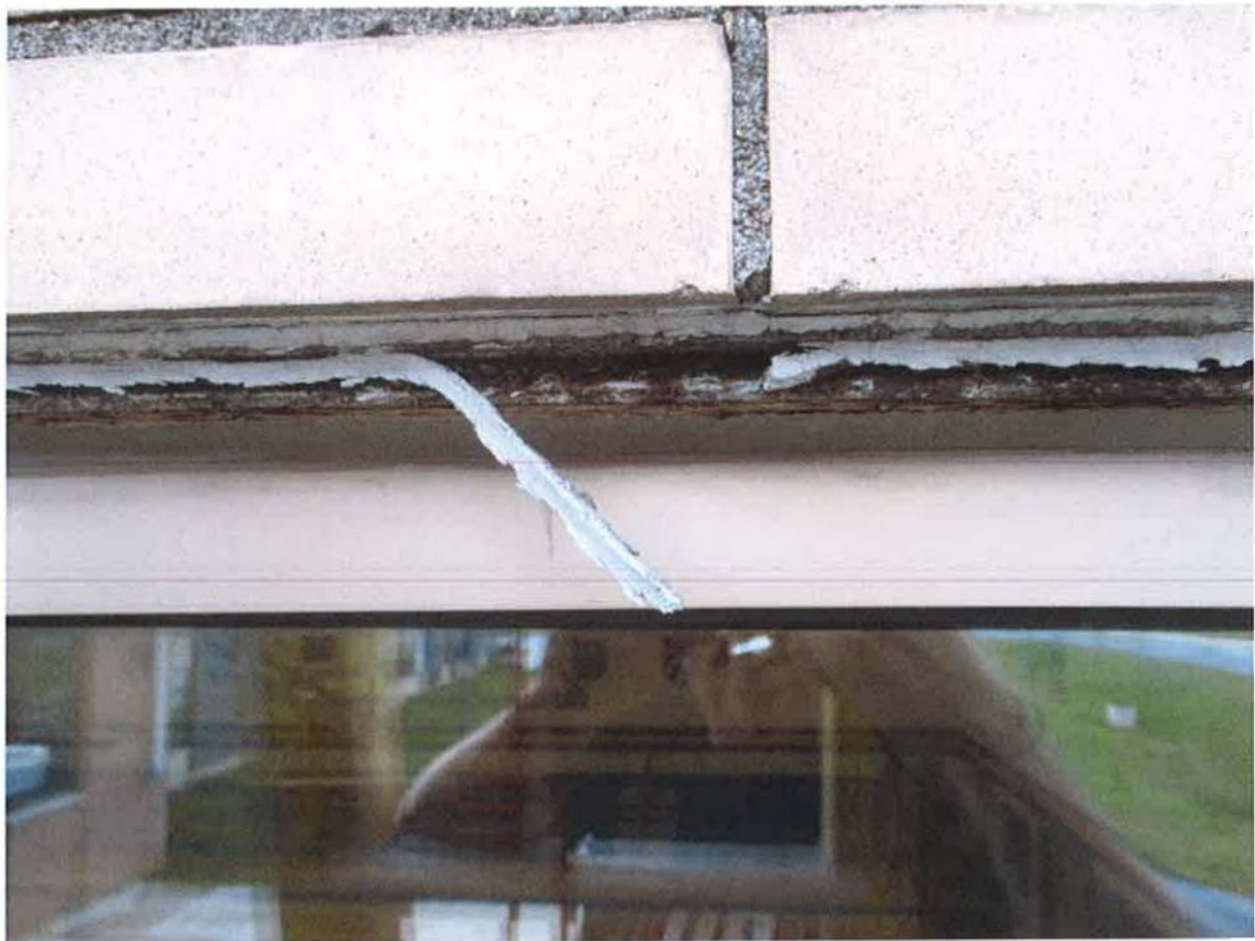
ALTERNATE #1

29 – Rusted steel lintel at south wall of Gym. Rust jacking has caused significant movement of the lower leg of the lintel.

Alternate No. 1 – Replace Lintels at Gym Windows at South Elevation

- Remove six courses of brick for 60 lf to access the damaged lintel. Provide shoring as necessary. Remove the rusted 4 x 3 1/2 steel angle via cutting and grinding. Gusset plates are assumed to be in good condition and will remain and be reused for anchoring the new steel angle.
- Install new steel angle of the same existing configuration and weld in place.
- Prime and paint steel angle after installation.
- Install new brick with flashing and weeps.
- Proper disposal of removed materials.

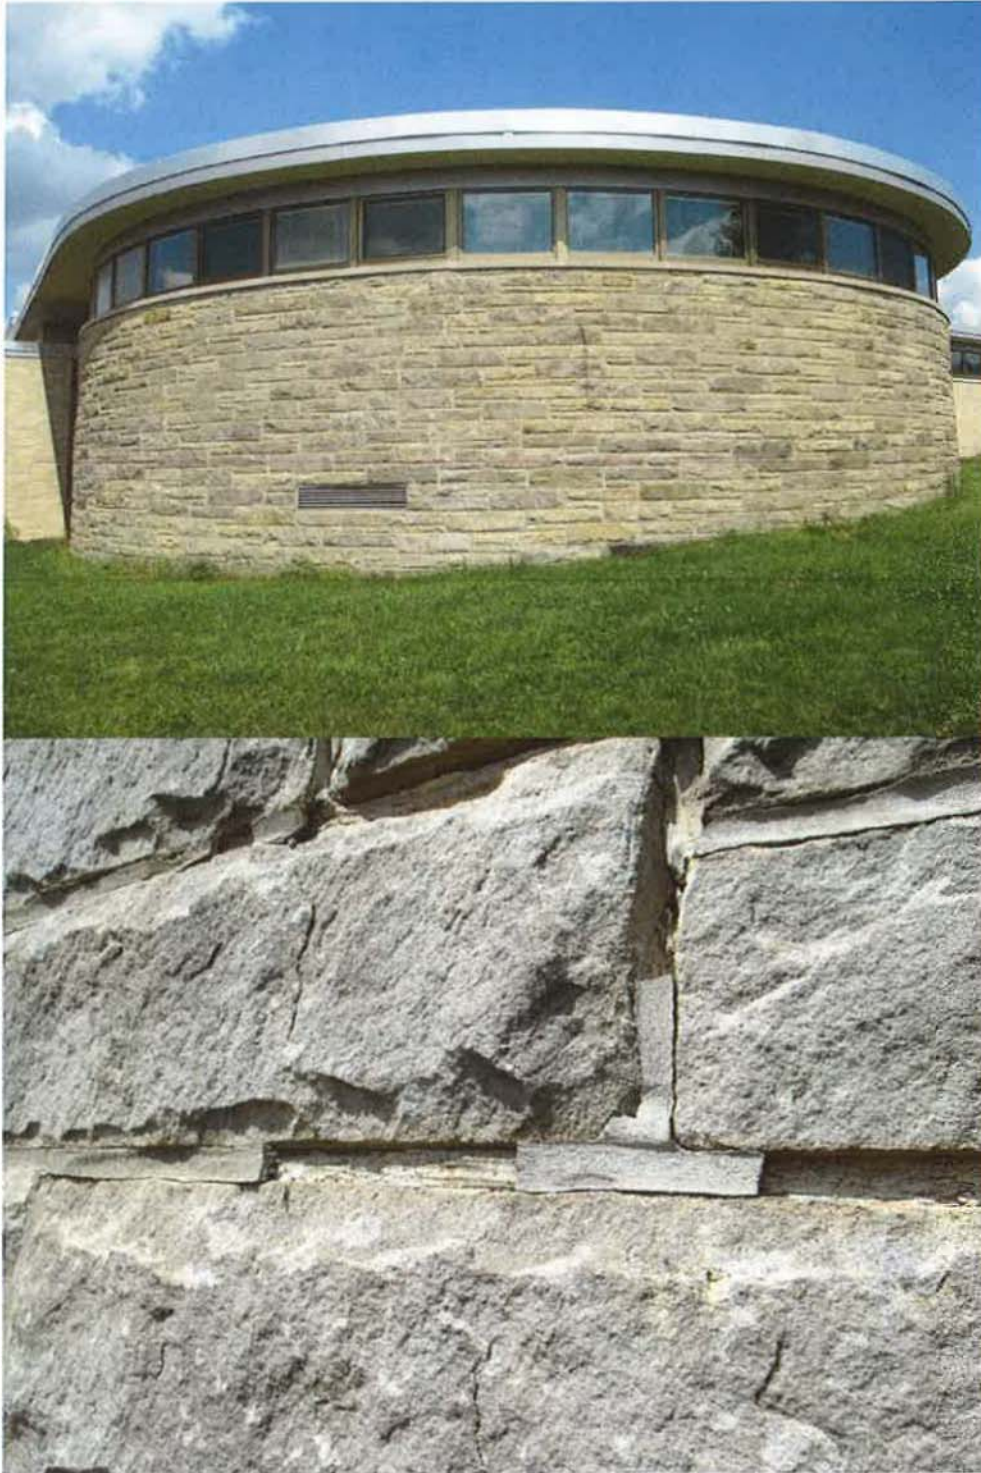
ALTERNATE #2

132 & 136 – Failed mortar joints at stone veneer of Band Practice Room.

Alternate No. 2 – Repoint Stone Veneer at Band Practice Room

- Repoint 300 lf of mortar joints in stone veneer that has failed.
- Replacement of any stone is NOT included.

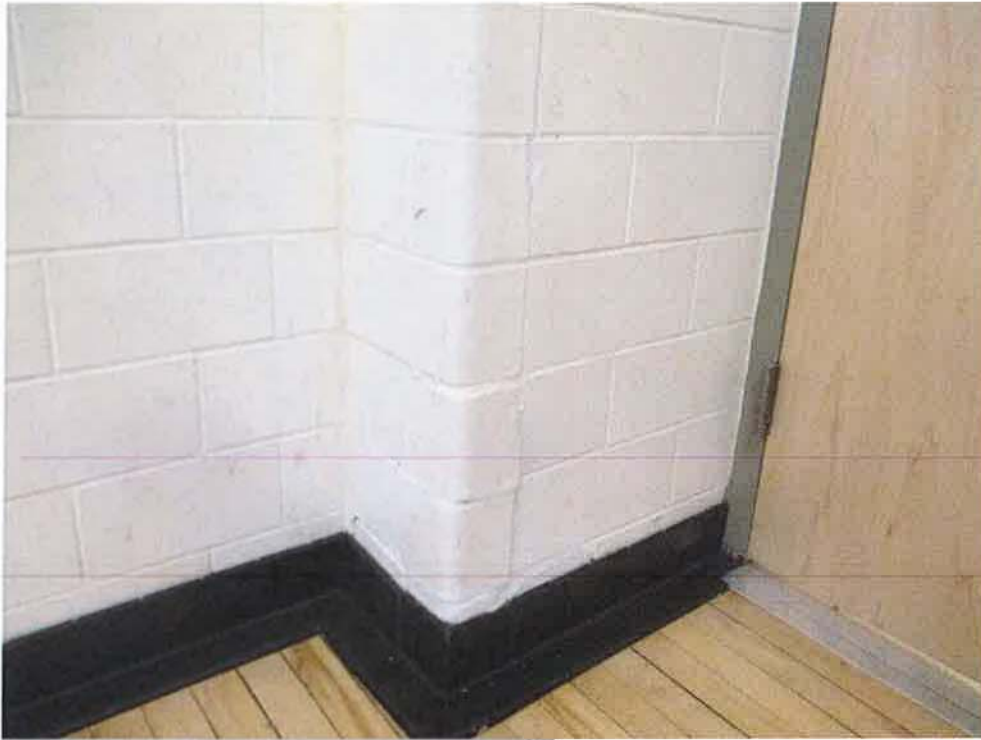
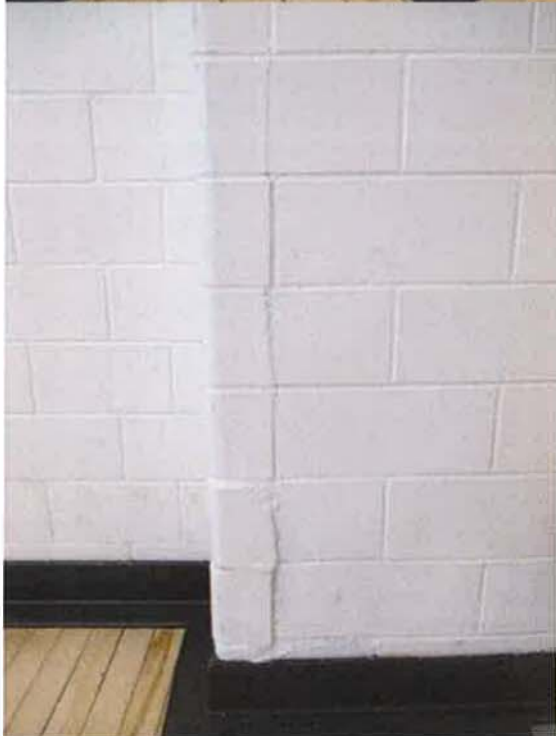
ALTERNATE #3

235 & 236 – Damaged glazed tile in Gym

Alternate No. 3 – Repair Glazed Tile Corner in Gym

- Remove and replace (9) nine bull-nose corner glazed tile that were damaged and/or cracked.
- Temporary enclosure and negative air are not included.
